NASA TECHNICAL MEMORANDUM

NASA TM X-73322

EXTERNAL TANK GASEOUS OXYGEN LINE SIMULATED LIGHTNING TESTS

July 1976

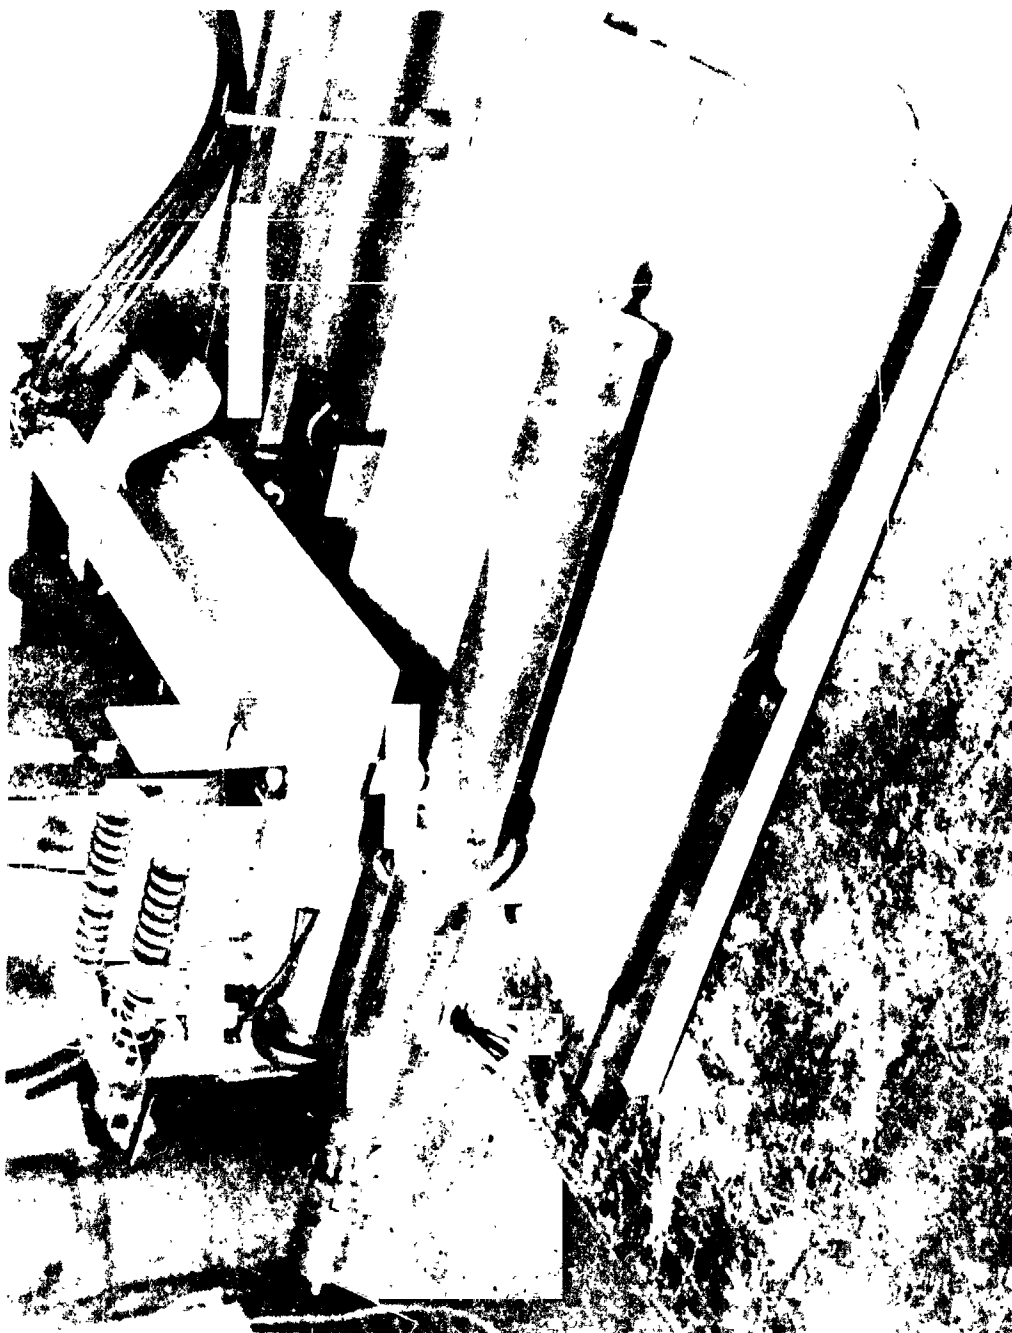
Figure 11. Test facility for the 400 amps continuous current tests.

To test and evaluate the 400 amp continuing current portion of the lightning model, five samples were tested: one sample was used for a stationary test (Table 4), and four samples were used for the swept stroke tests (Tables 5 through 8). The facility shown in Figure 10 was used to perform all of the 400 amp tests. A photograph of the test facility and the GOX line sample is shown in Figure 11.
